Situation Photo Log

Wednesday, June 6, 2012

Kalamazoo River / Enbridge Spill

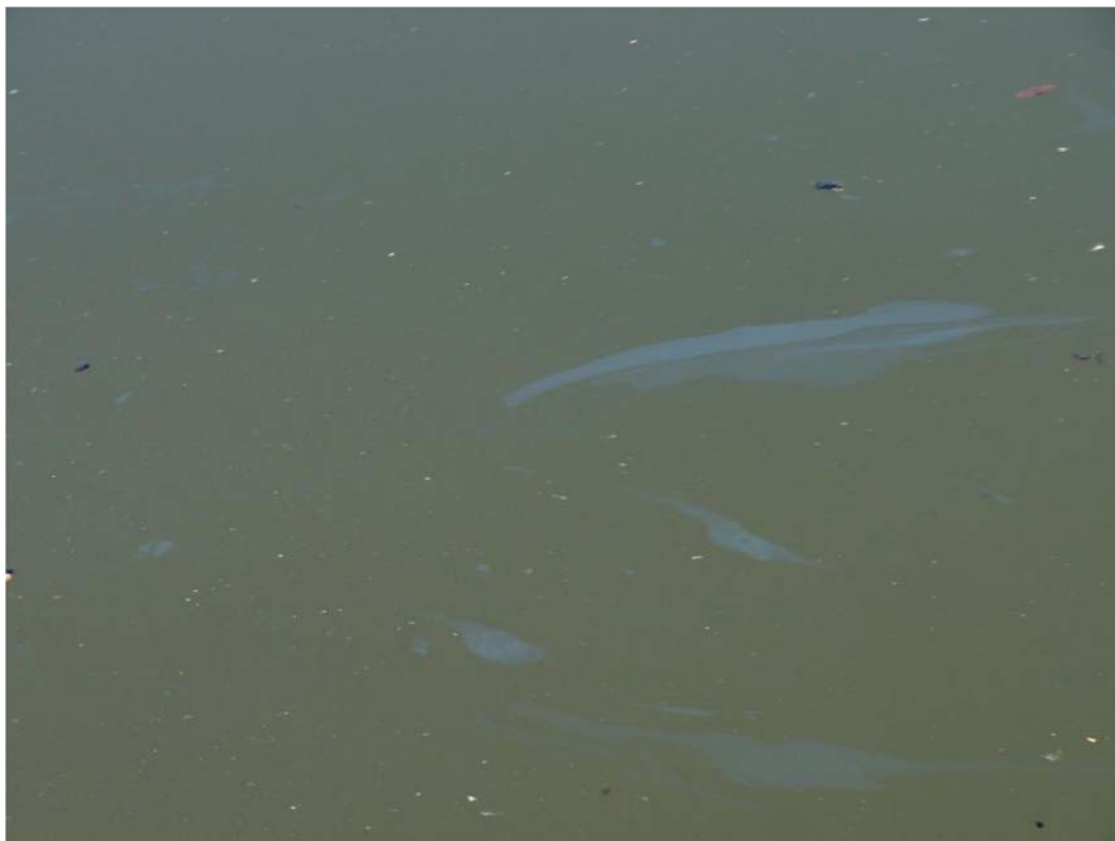
24. MP37.75 Sheen observed upstream of the E4 boom.

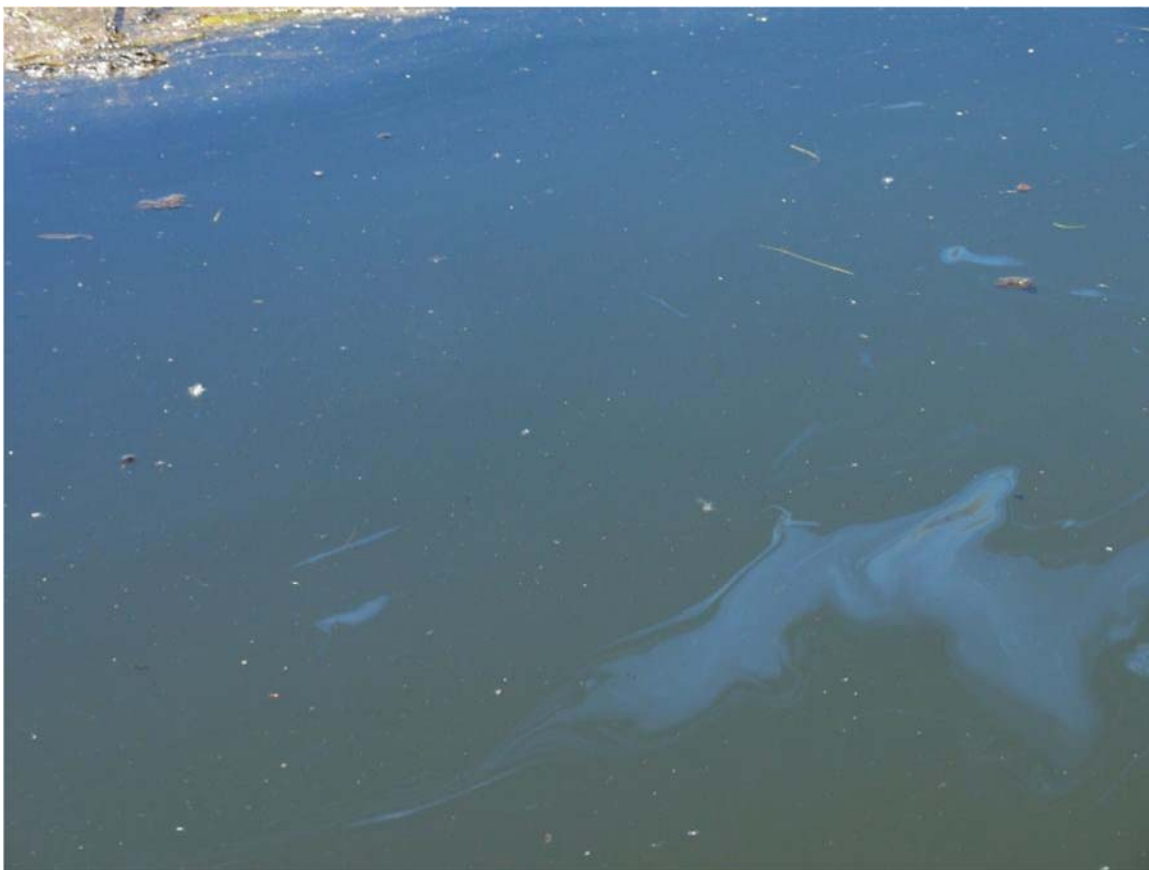
25. MP37.75 Sheen observed upstream of the E4 boom.

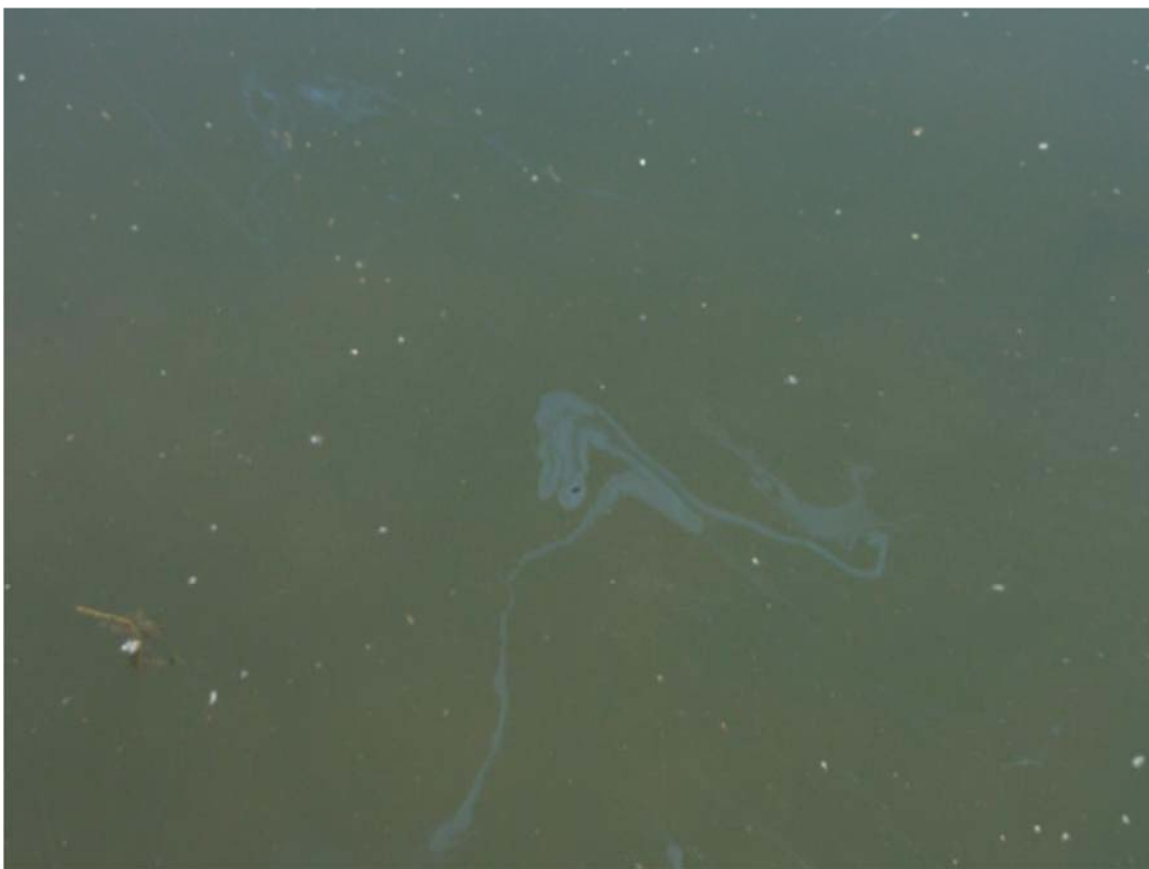
26. MP37.75 Sheen observed upstream of the E4 boom.

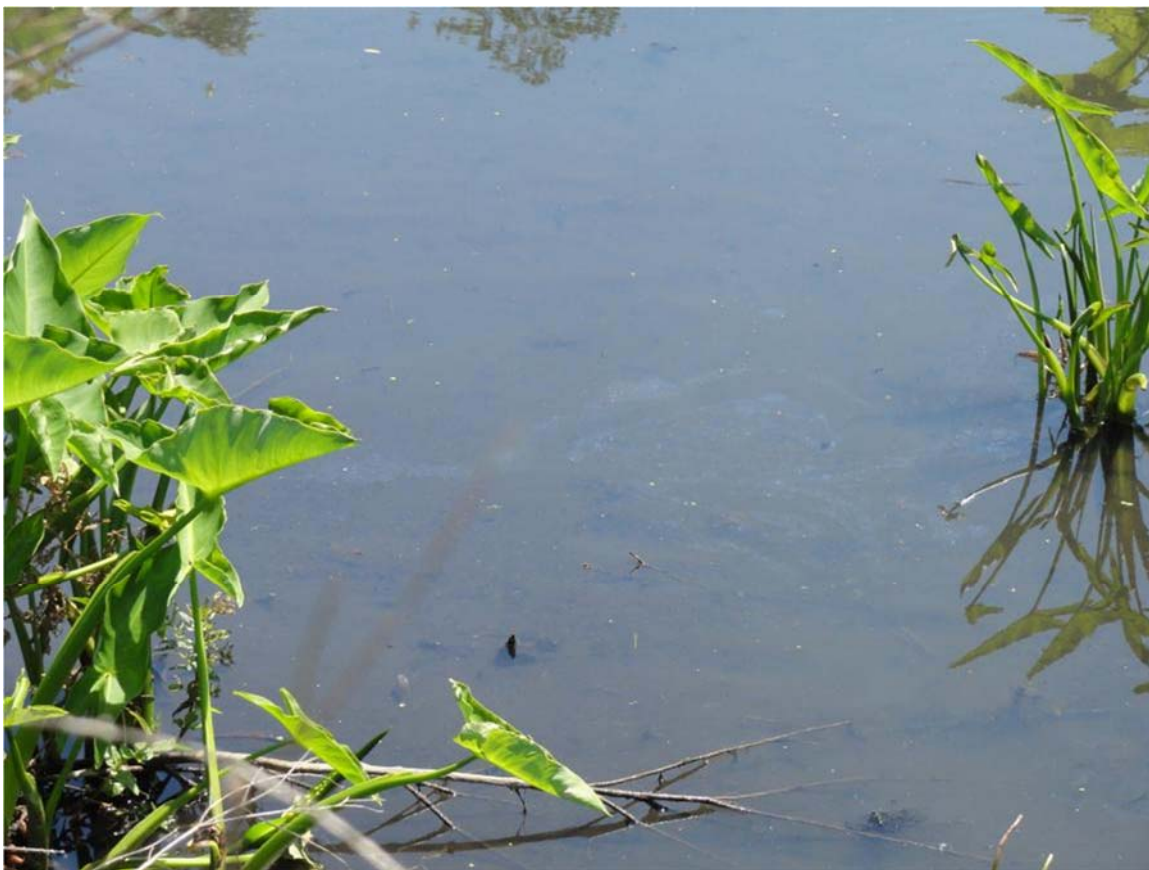
27. MP37.0 Island located in the eastern portion of the Delta, sheen observed.

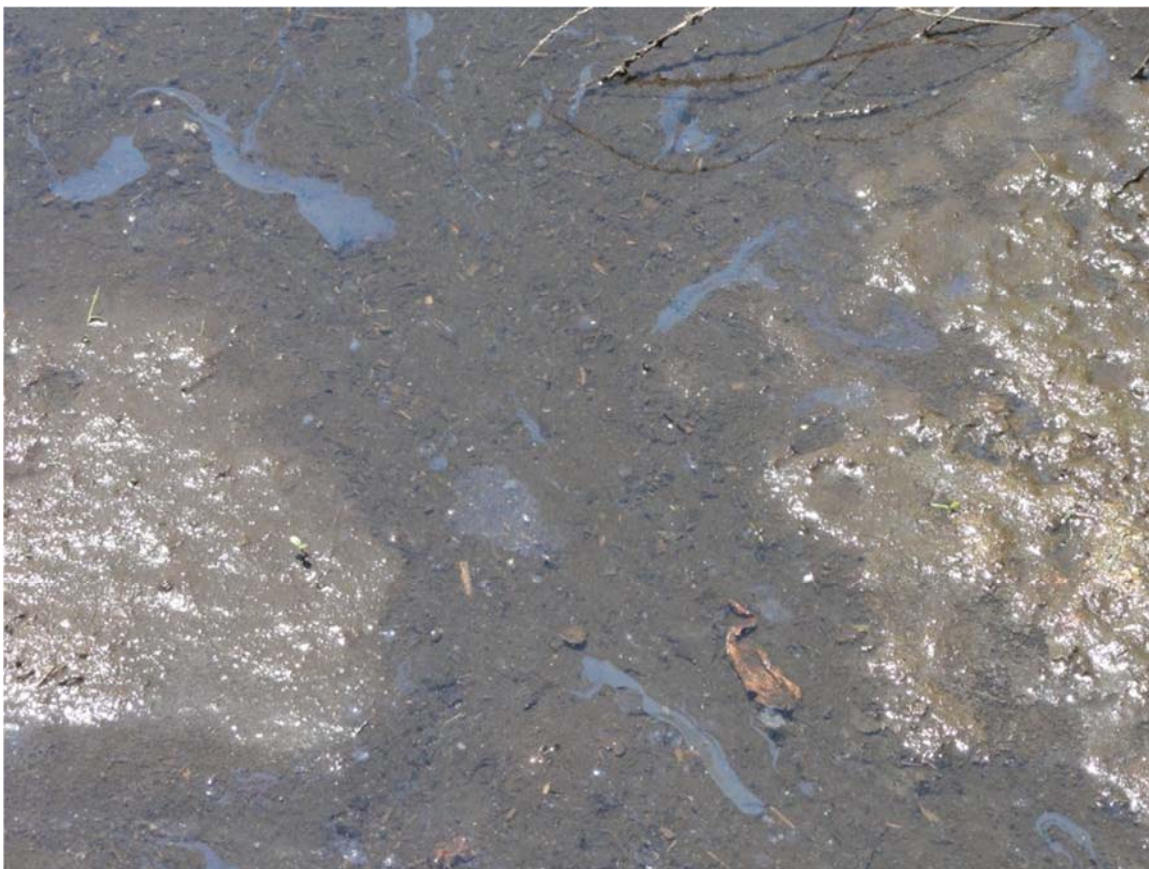
28. Large Island located in southeast corner of the Delta sheen observed.

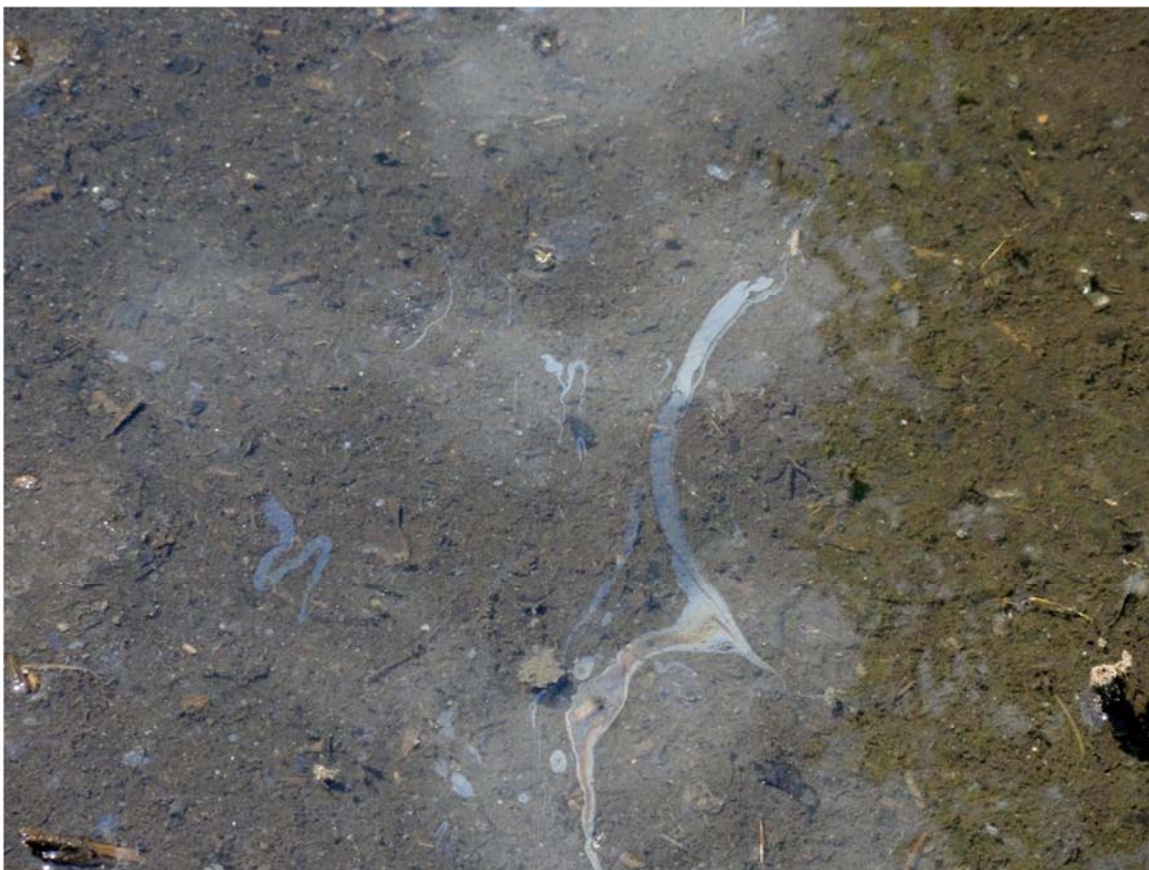
29. Large Island located in southeast corner of the Delta sheen observed.

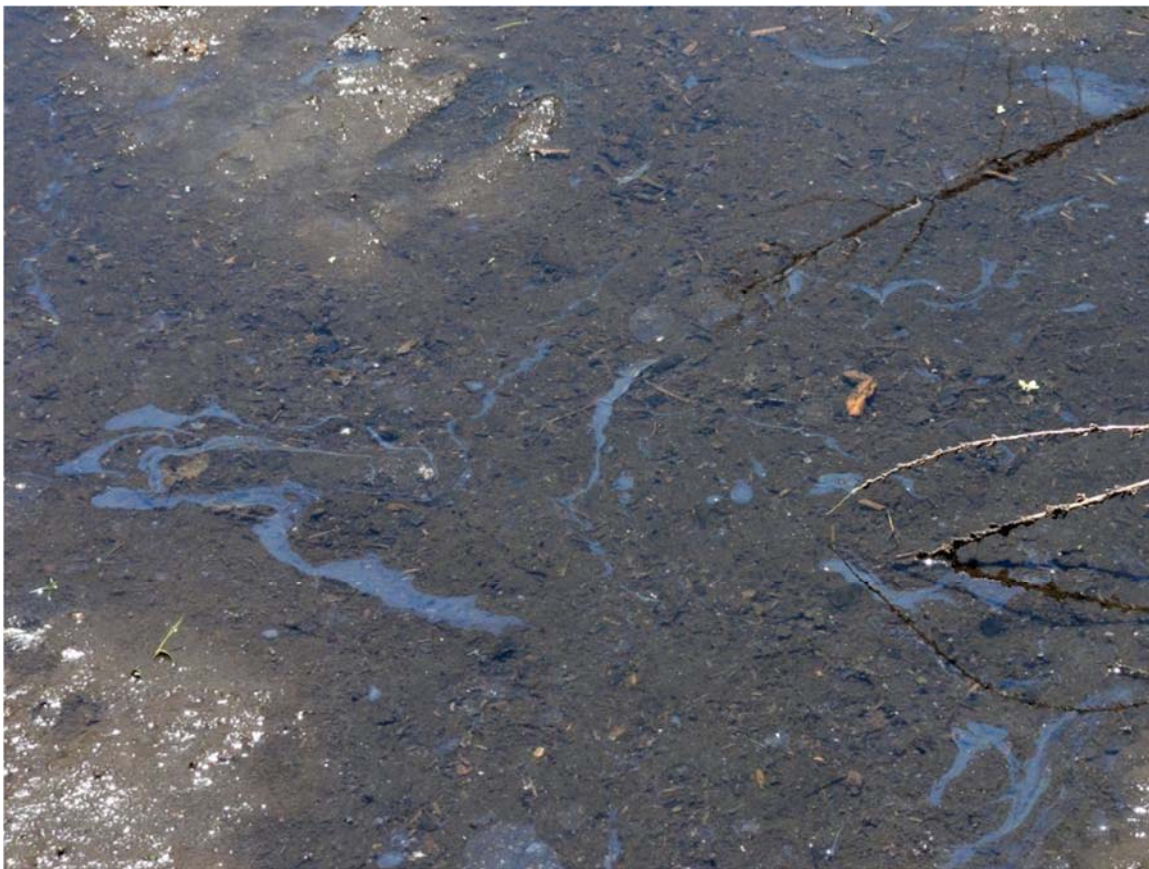
30. Large Island located in southeast corner of the Delta sheen observed.

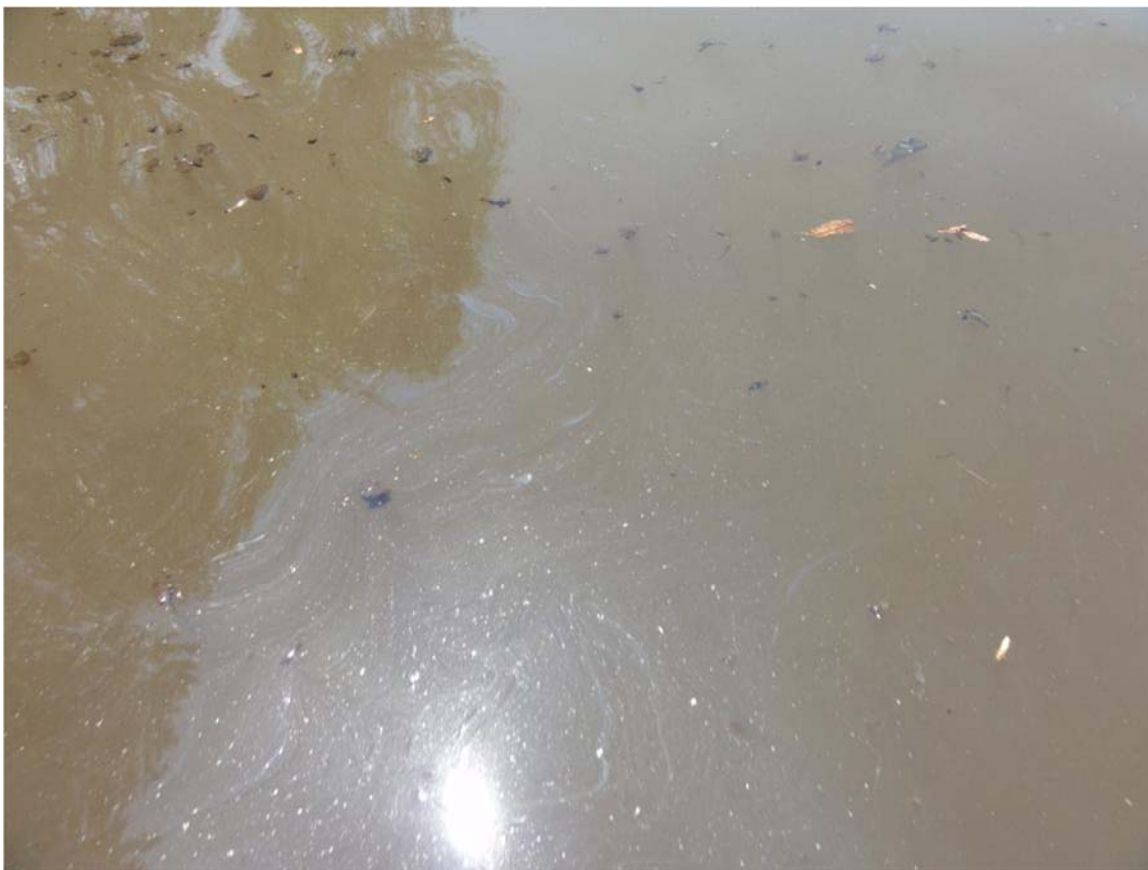
31. Sheen observed in southeast corner of the Delta.

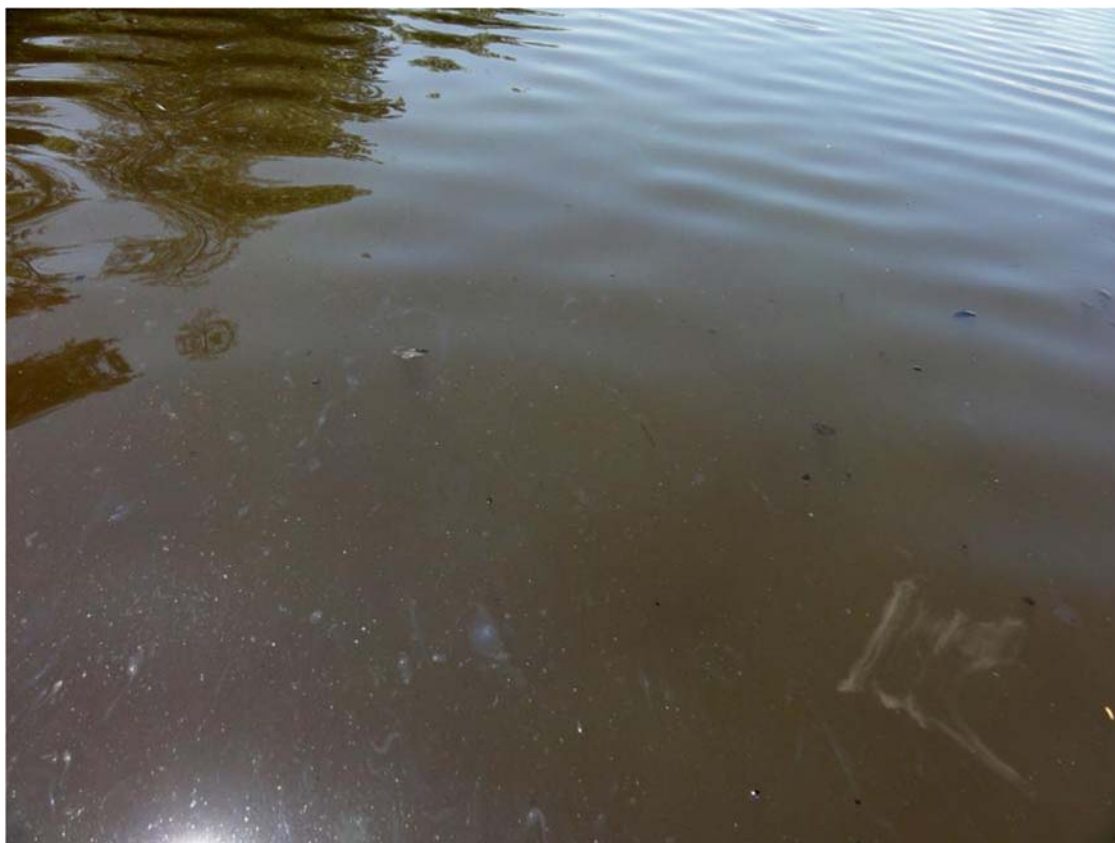
32. Sheen observed in southeast corner of the Delta.

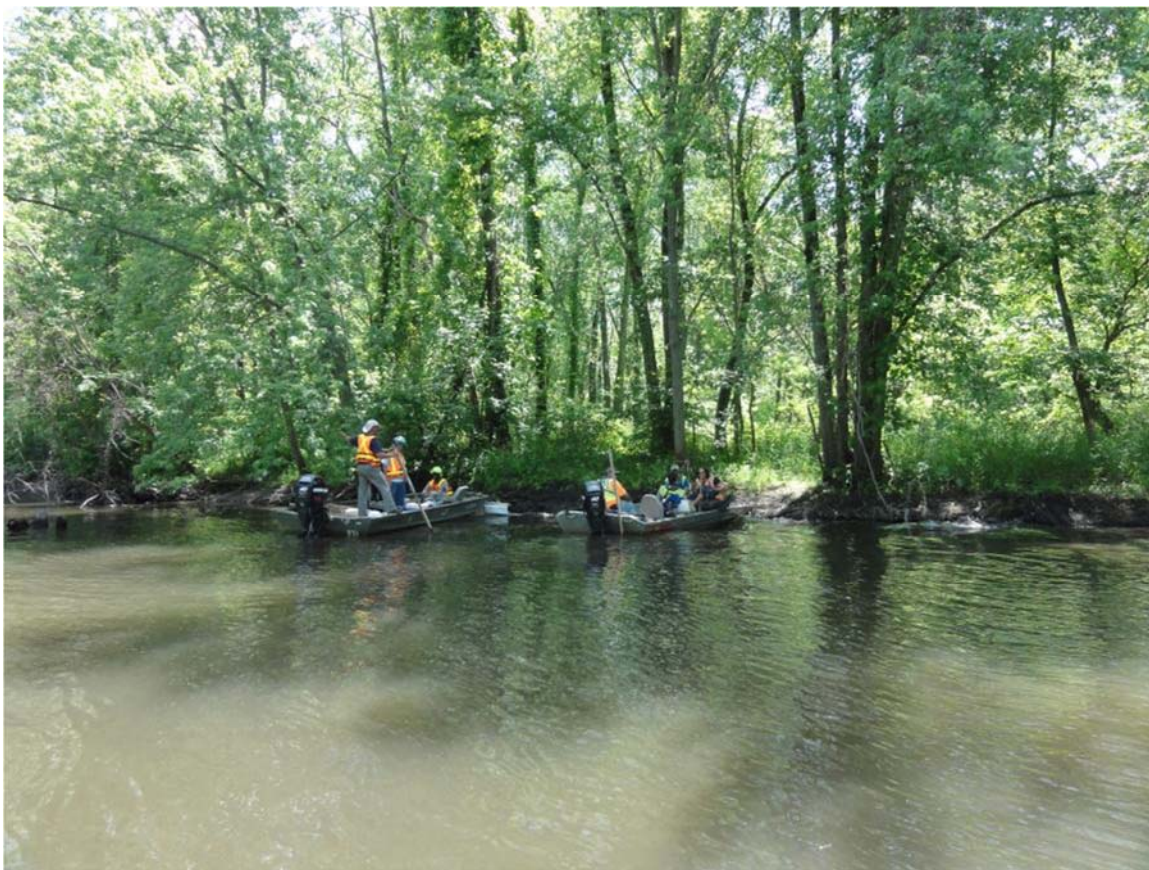
33. MP30.75 Poling crew observed.

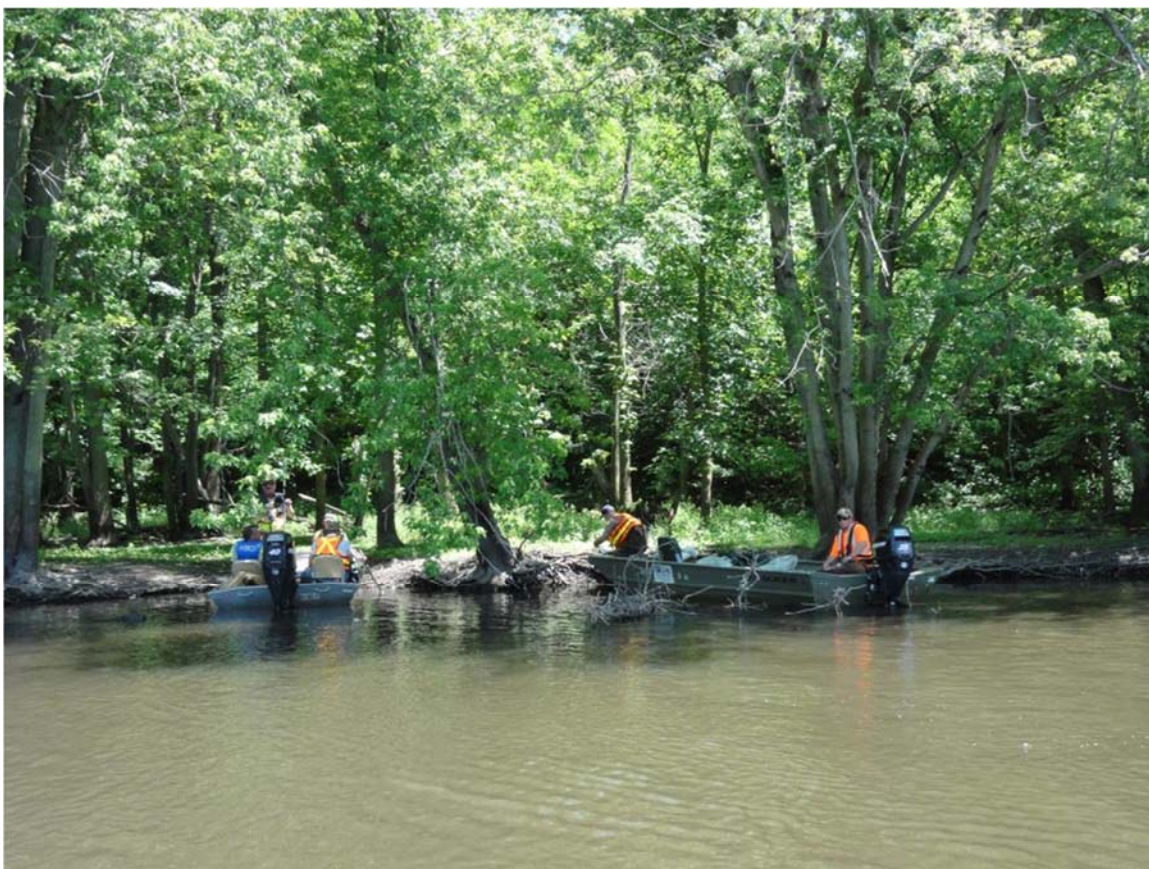
34. MP29.5 Poling crew observed.

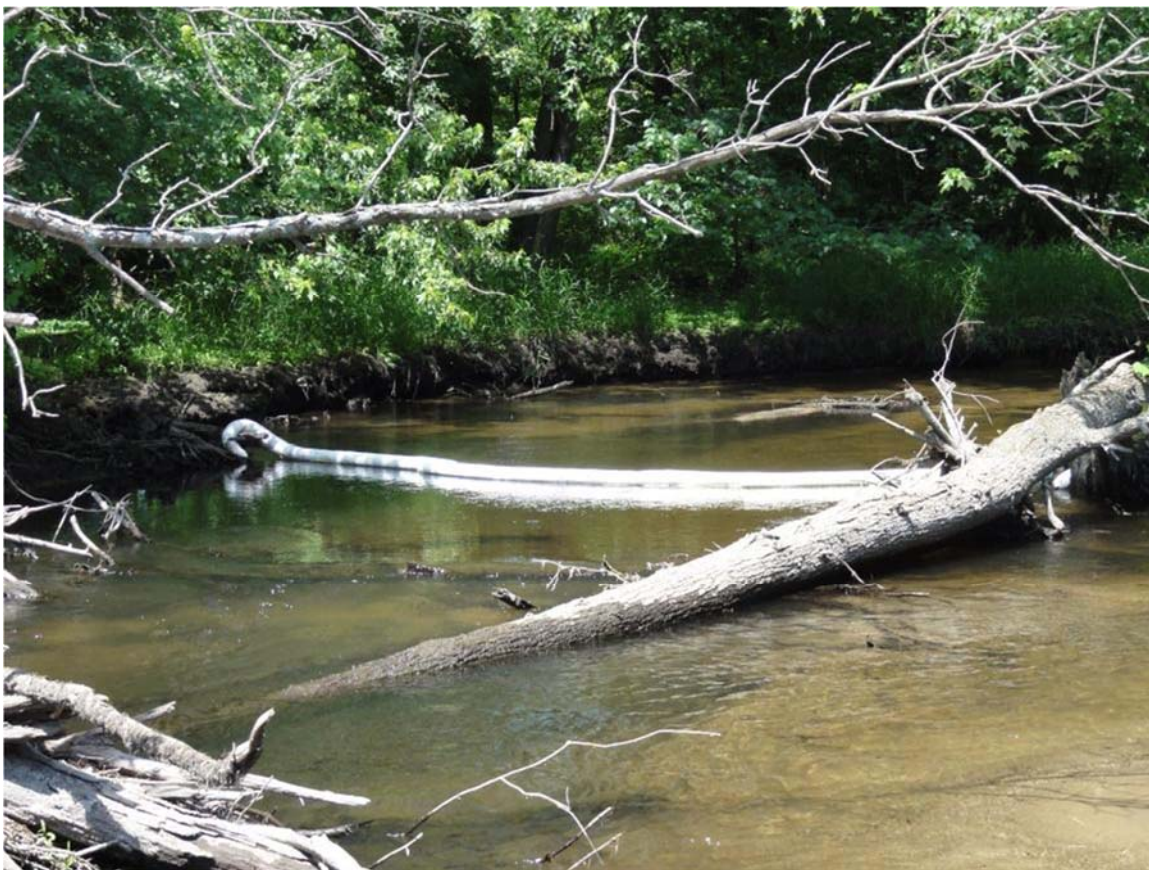
35. MP29.25 absorbent boom placed in downstream portion of channel.

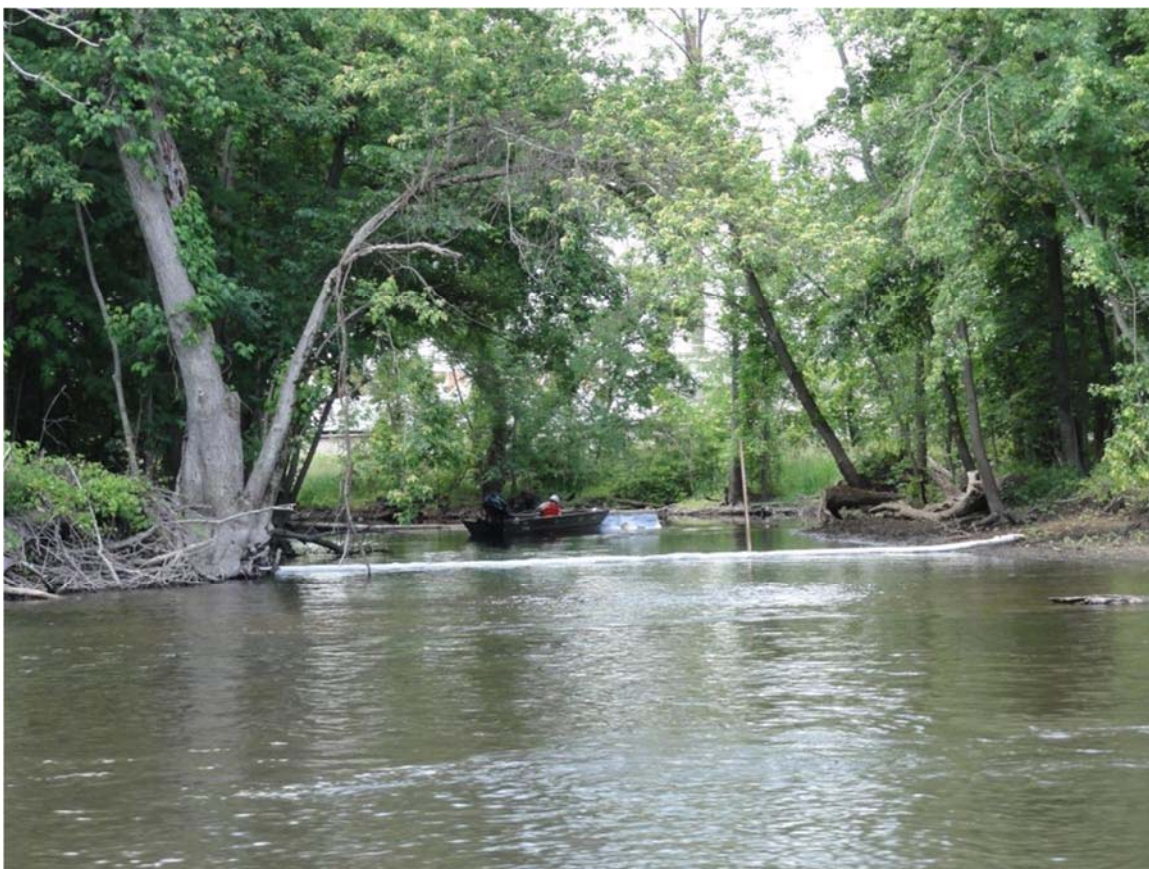
36. MP29.0 absorbent boom placed in upstream end of channel.

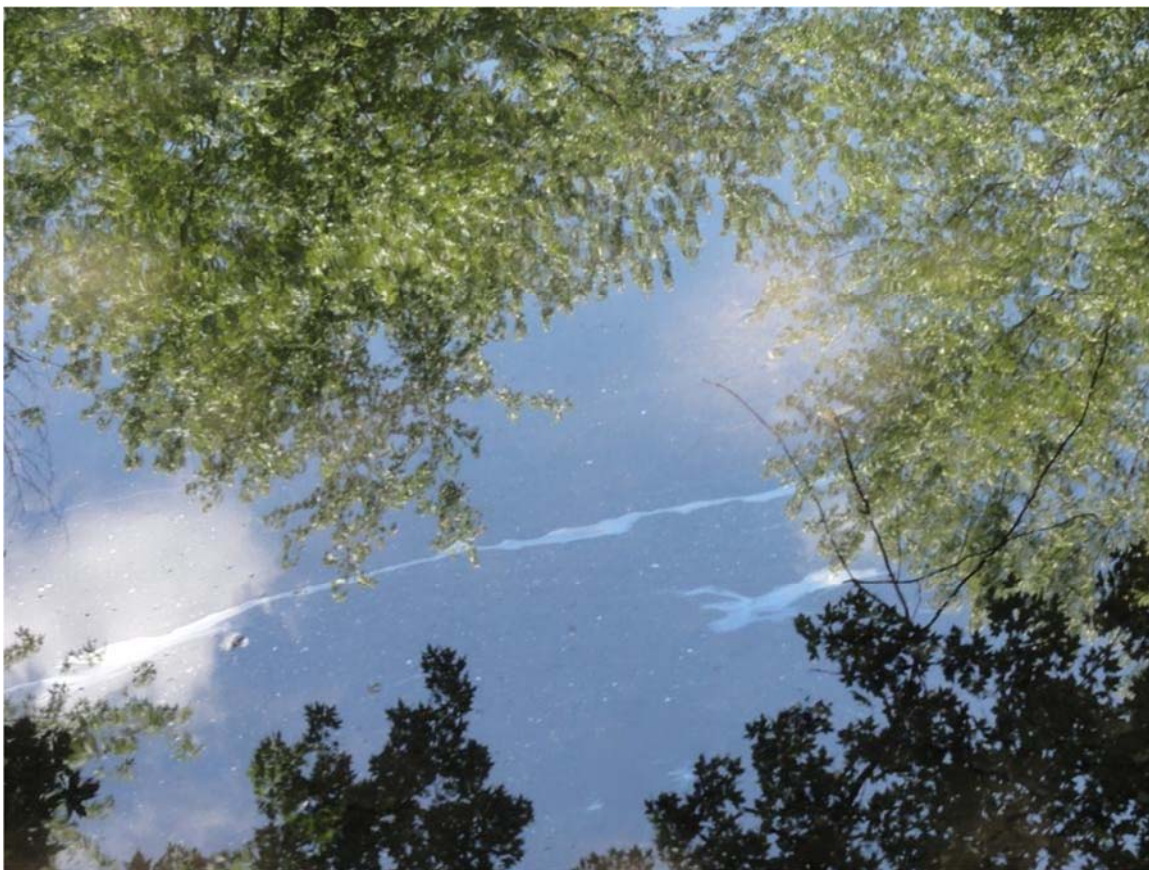
37. MP26.5 back channel sheen observed.

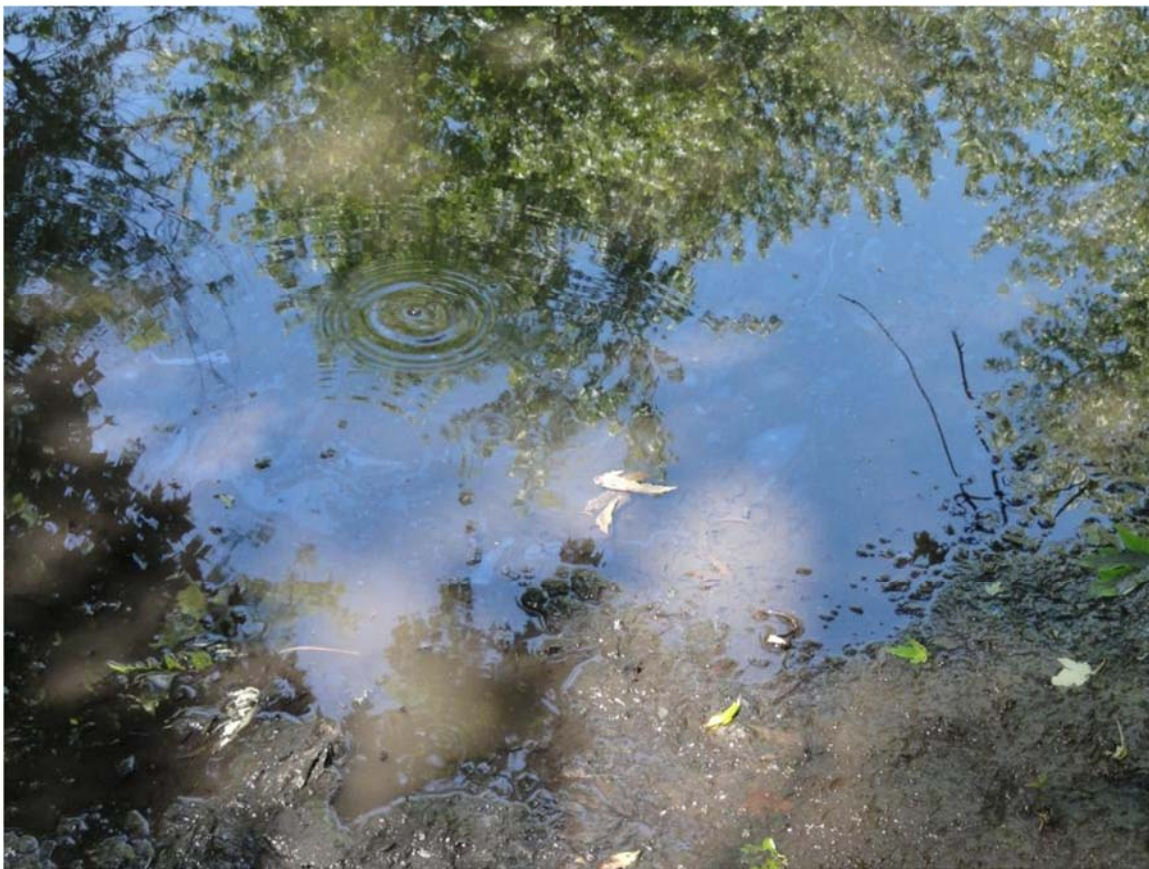
38. MP26.5 back channel sheen observed in areas stepped in.

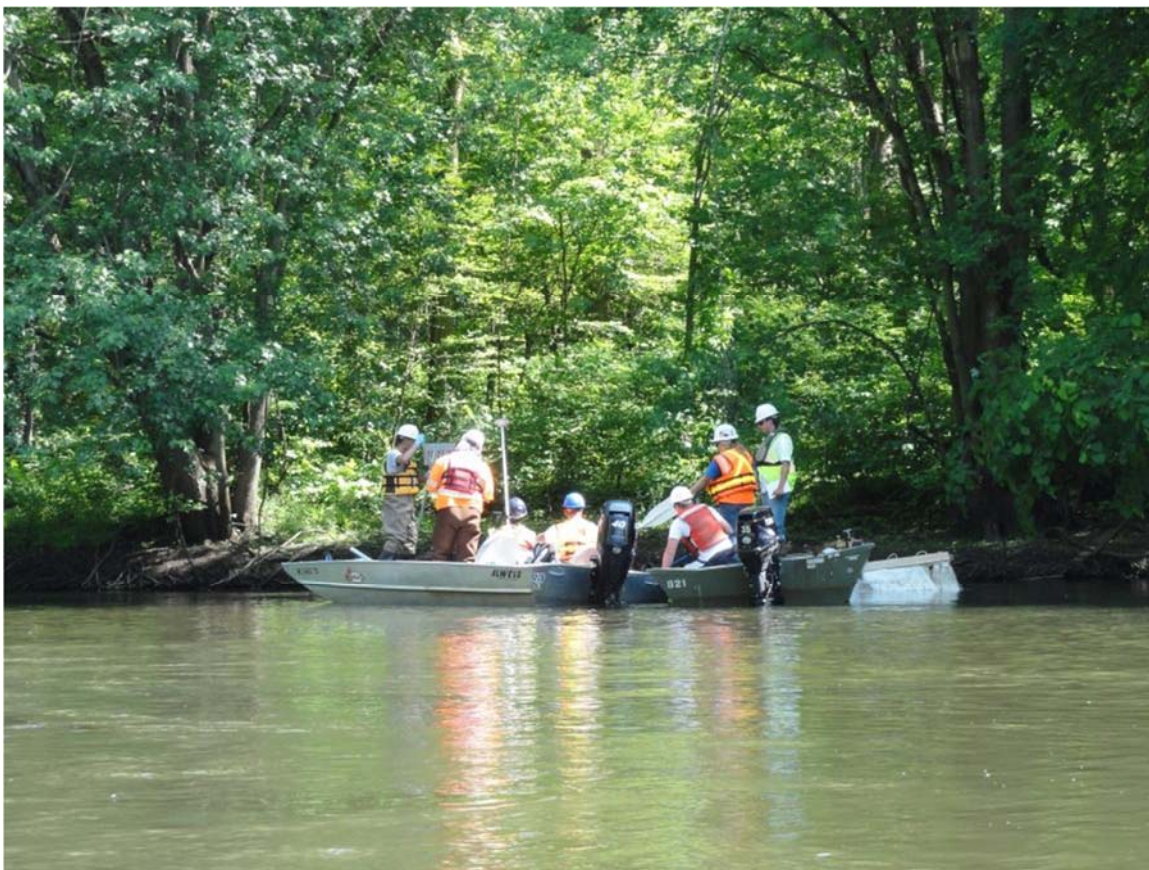
39. MP22.25 Poling crew observed.

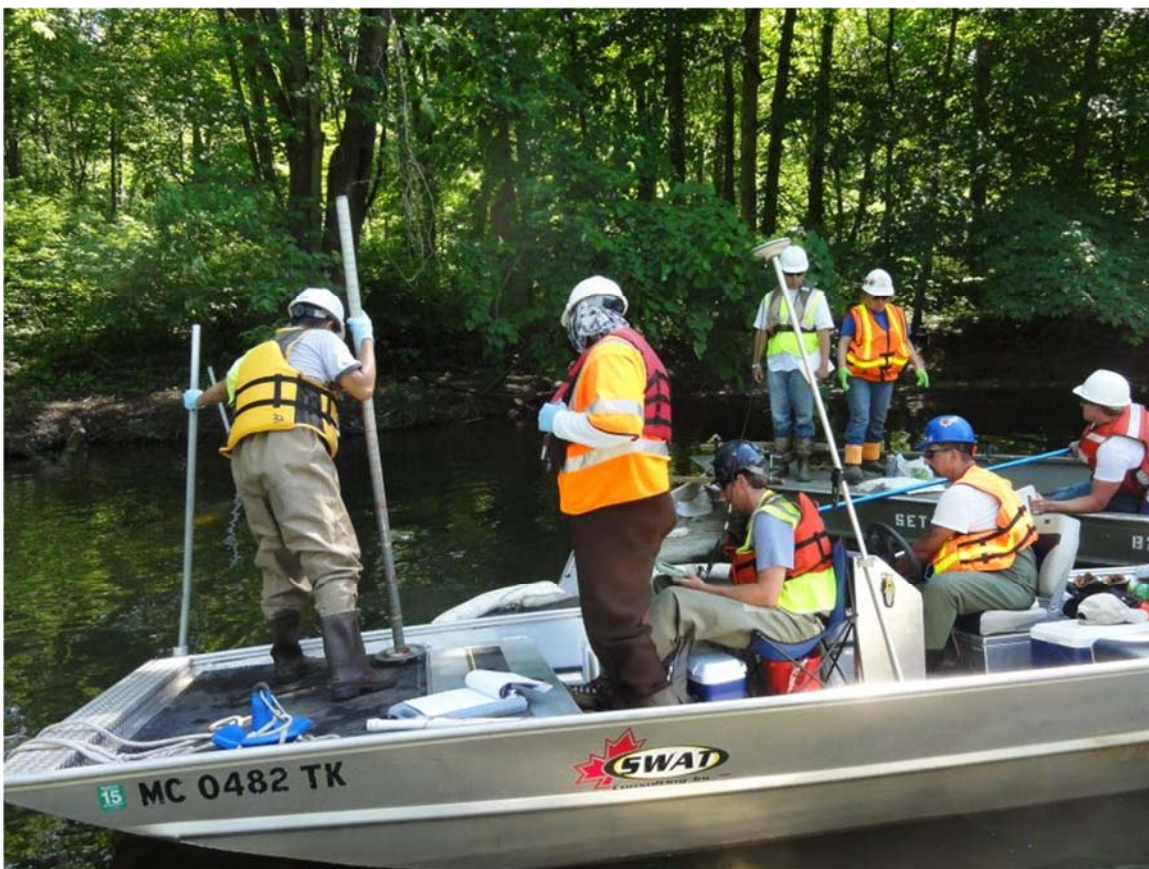
40. MP22.25 Poling crew observed.

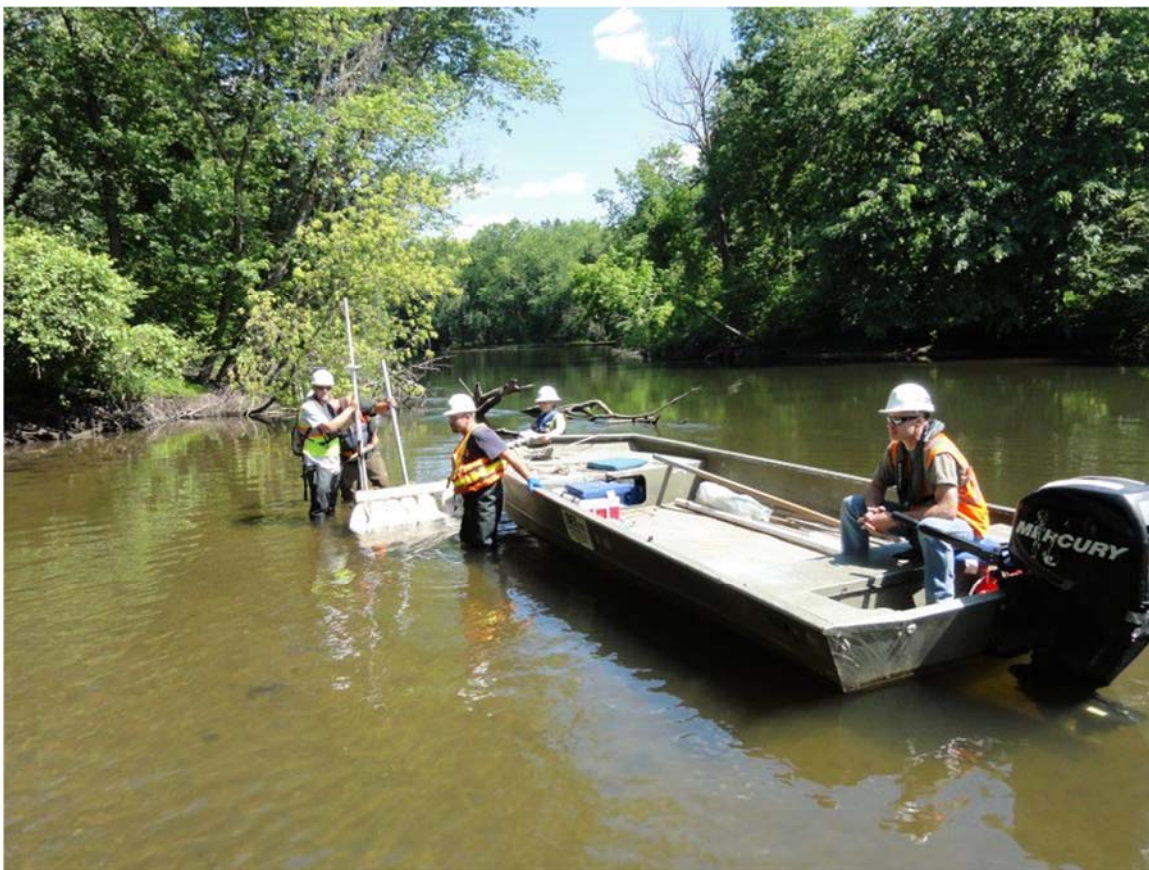
41. MP22.25 Poling crew observed.

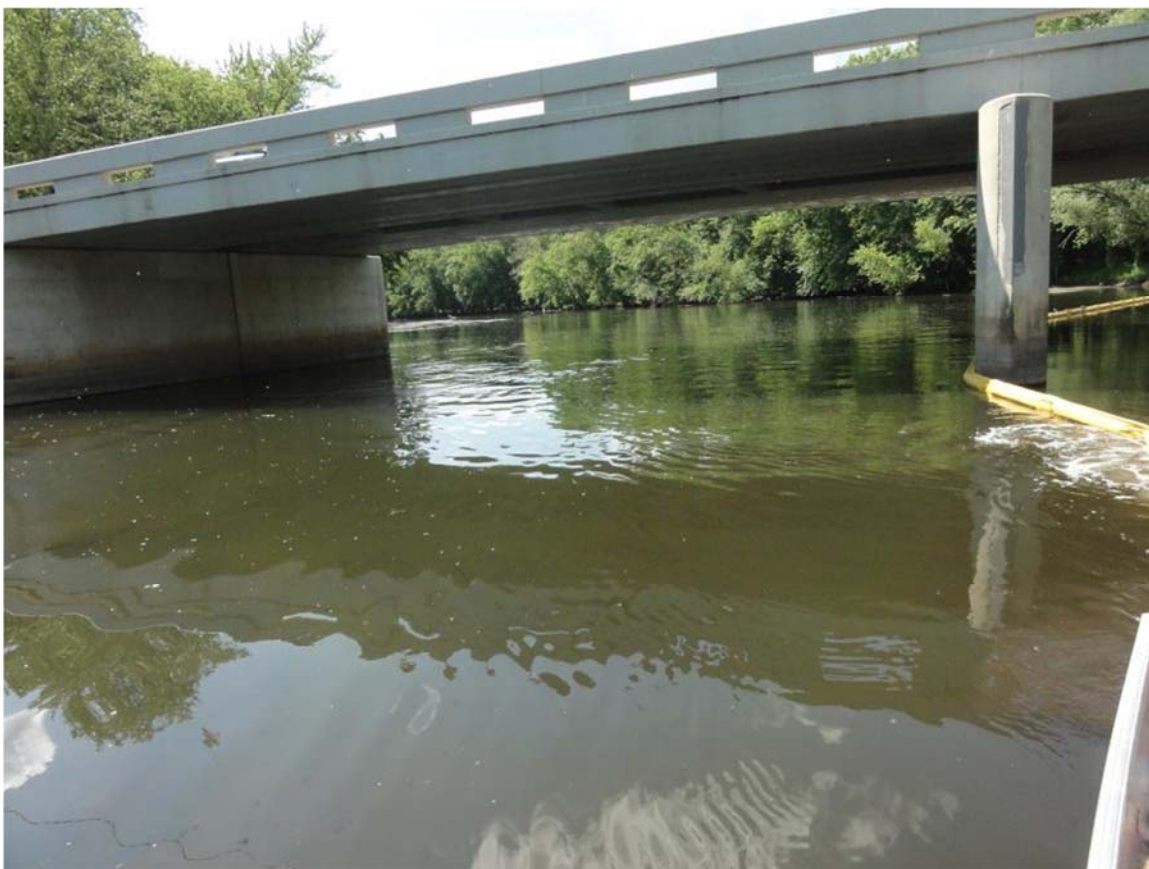
42. MP21.5 sheen observed within river channel.

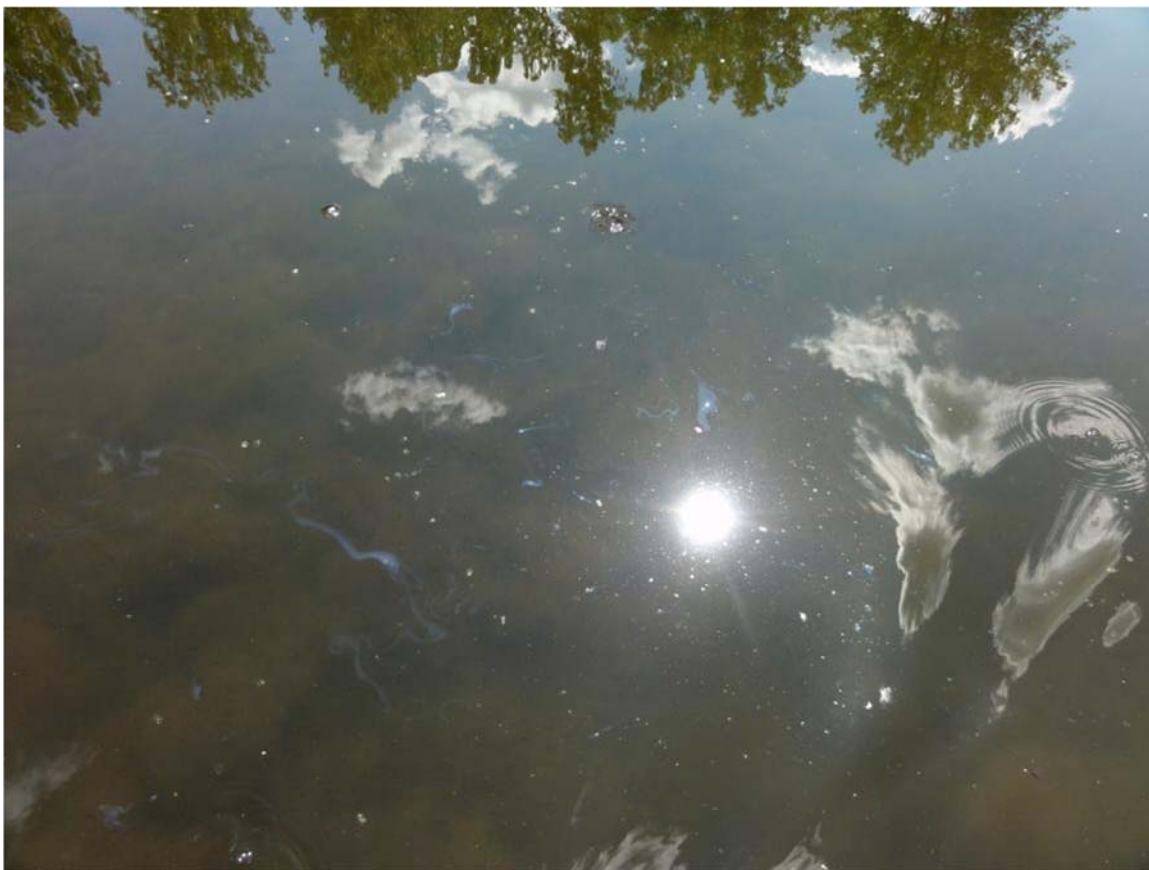
43. MP21.5 sheen observed in river channel.

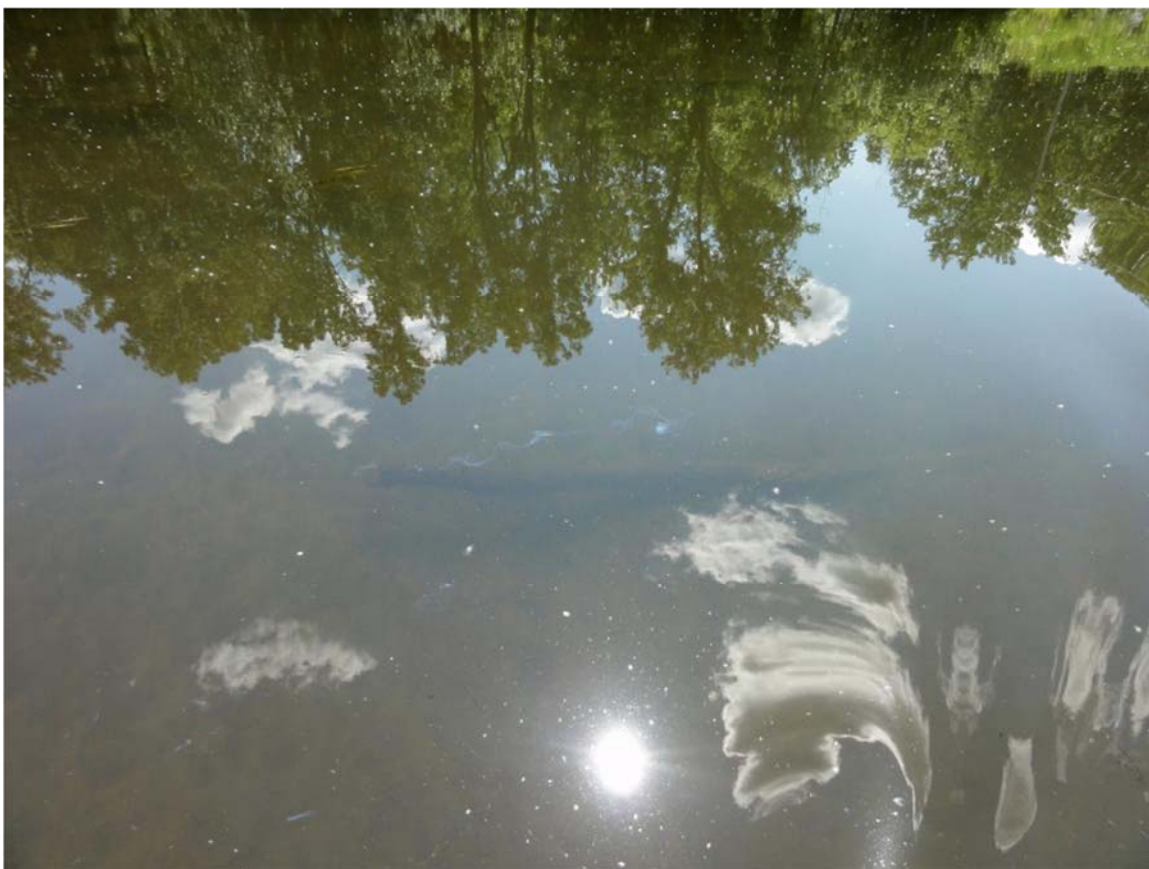
44. MP21.5 sheen observed in river channel.

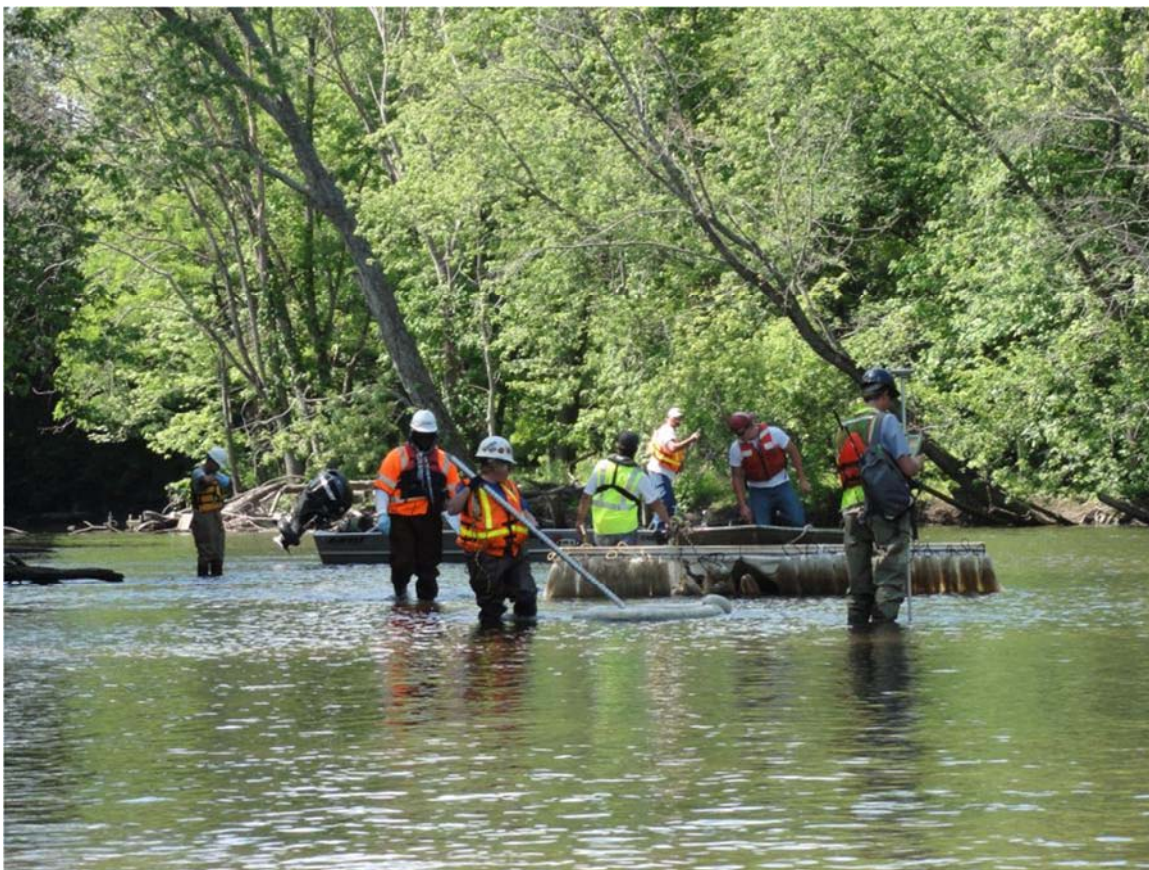
45. MP22.75 Poling crew observed.

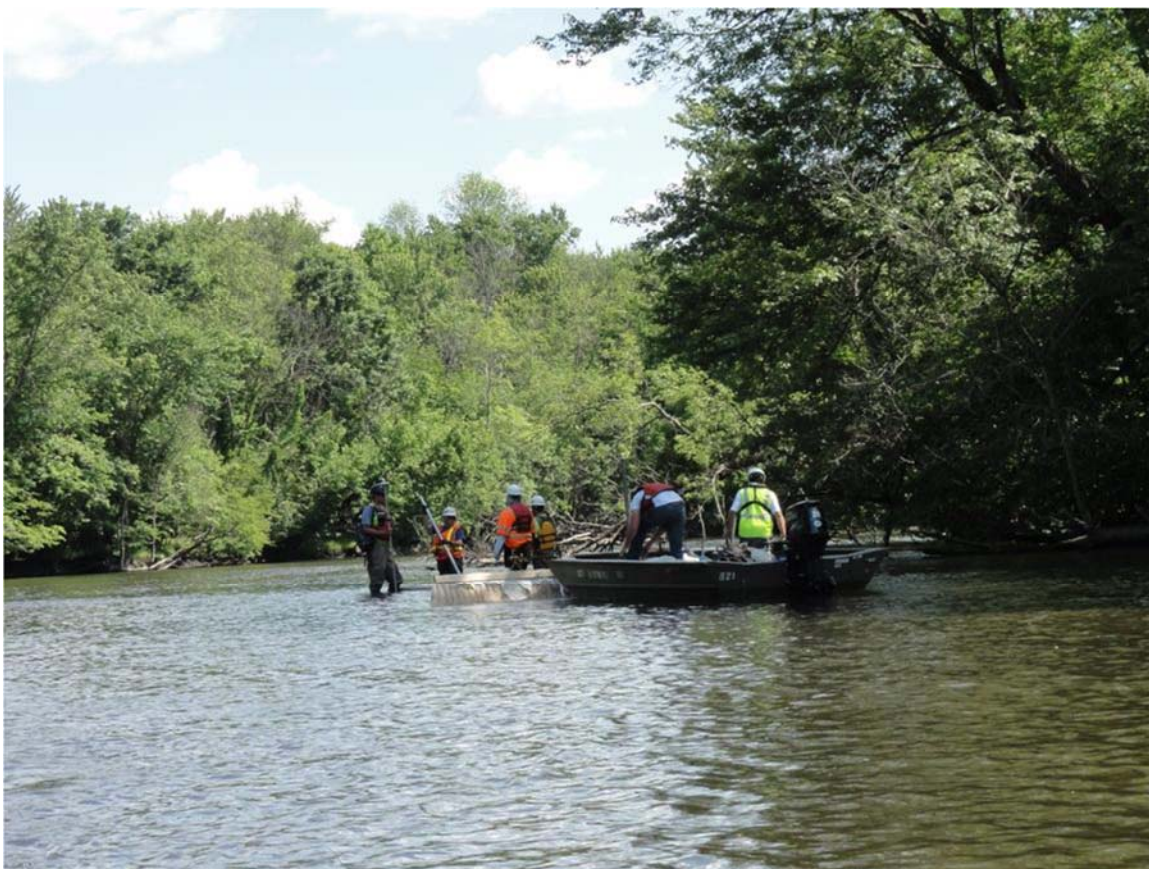
46. MP22.75 Poling crew observed.
